# ROOF-RESTORATION

**Made Easy with FERTAN – Save 90% or MORE over Replacement Cost**

## CASE STUDY (PICTURES ON THE FRONT PAGE)

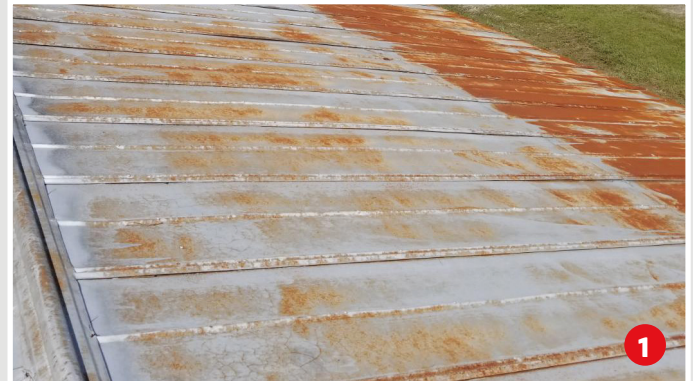
Rusted metal roof

- Case Study of Real Life Customer in FL
- Roof showed severe rust and just started leaking slightly
- Either buy new roof for over \$20k or repair and restore with Fertan and SAVE BIG
- Product needed: FERTAN Rust Converter and Epoxy primer
- Application methode: 1) Rust Converter Spray Gun 2) EP Roller
- Resources/Time Spent: Rust converter application: 1 person, 8hrs
- Epoxy Primer: 1 person 20 hrs
- Cost savings: over 90 % vs. roof replacement
- **Result: Fully restored roof**
- **Coverage Area:**
- Rust Converter: 1 Gal. is enough for 500 sqft.
- Epoxy Primer . 67.6 fl. oz. is enough for 130 -140 sqft.

Clean the roof of any dust, dirt and loose rust particles. If possible with a high pressure water cleaner.

Then apply FERTAN RUST CONVERTER (see backside for product details) by brush, roller or spray on the wet surface and let it react for app. 24 hours at min 68°F.

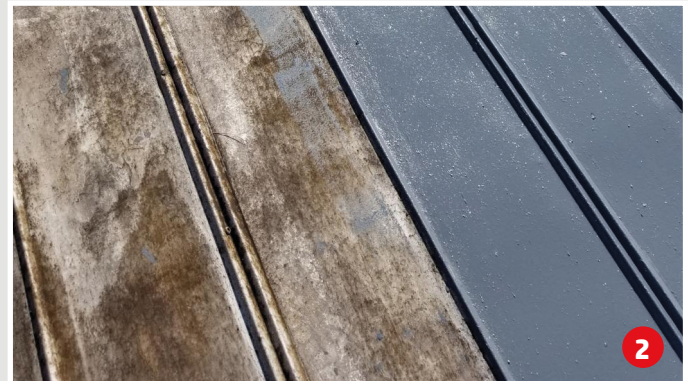
Left side: after applying the FRC, right side after applying FEP over FRC

If the surface is exposed to sunshine, gently wet the surface after 2 – 3 hours with fine water fog to prevent the product from drying out before it has fully reacted. After the reaction time the surface is now black or blue, rinse the surface with plenty of water and wait until the surface is completely dry.

Now apply a primer, like FERTAN Epoxy primer (see backside for product details). EPOXY coatings should be etched if they are being overpainted. FERTAN surfaces must never be etched.

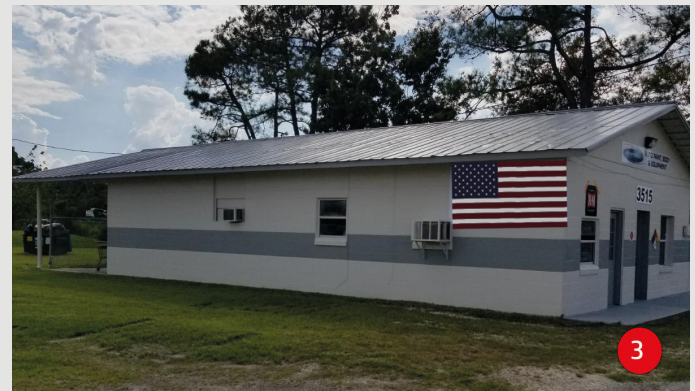
Fully restored roof, brand new look and long term rust protection for up to 90% less cost than a roof replacement
